**E-16-123B Refrig. Condenser Fan**

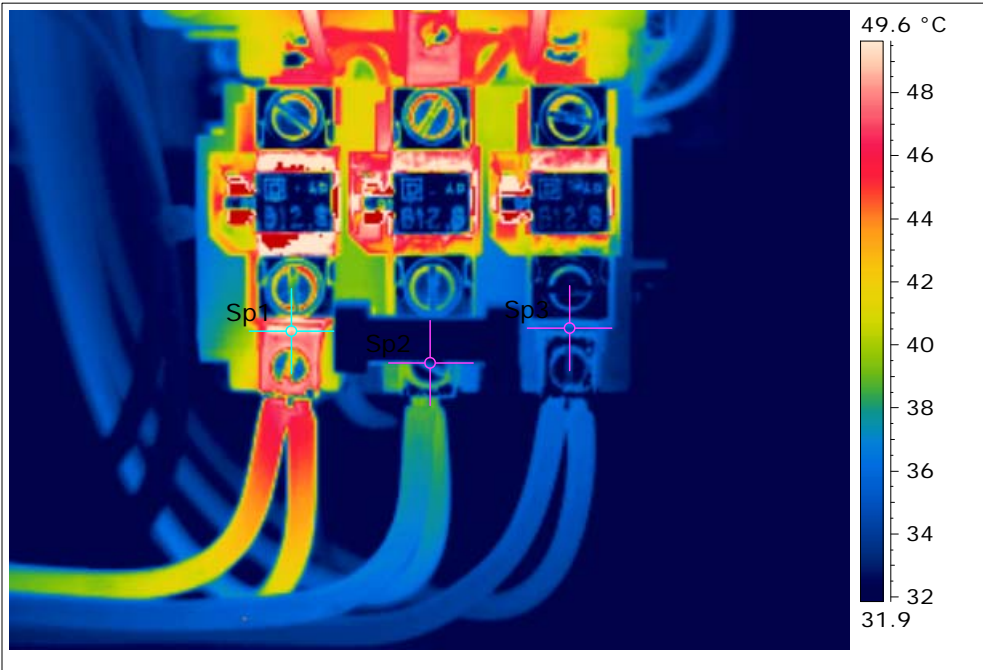
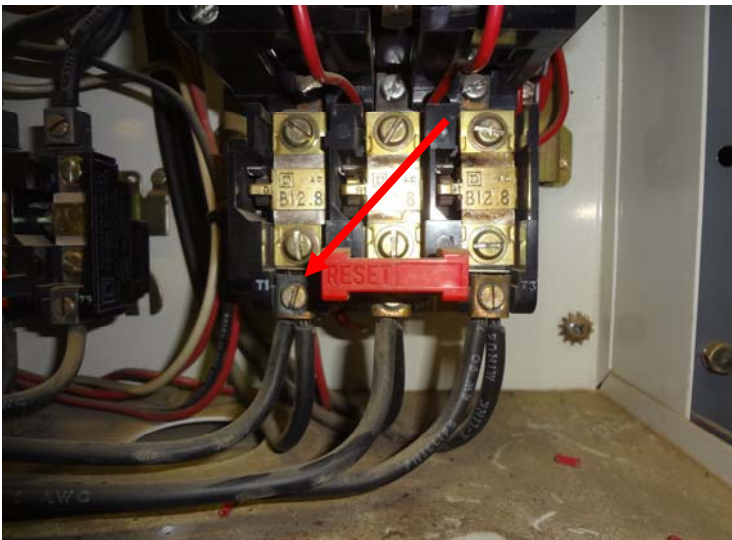
Repair Probable Poor Connection @ A Leg on the Load Side of the Starter.

SP1 = A Leg  
SP2 = B Leg  
SP3 = C Leg

MCC Location: Main Electrical Building MCC #4	Filename: IR_37058.jpg
Equipment: E-16-123B Refrig. Condenser FaN	Camera Type: FLIR GF309
Load Factor: Balanced Load @ 7 Amps	Camera Lens: FOL23
Fault: Probable Poor Connection	Emissivity: 0.96
Date: 09/03/2015	Sp1: 48.4 °C
Time: 8:09:52 AM	Sp2: 34.9 °C
	Sp3: 34.1 °C

**Repair @ Next Downtime**

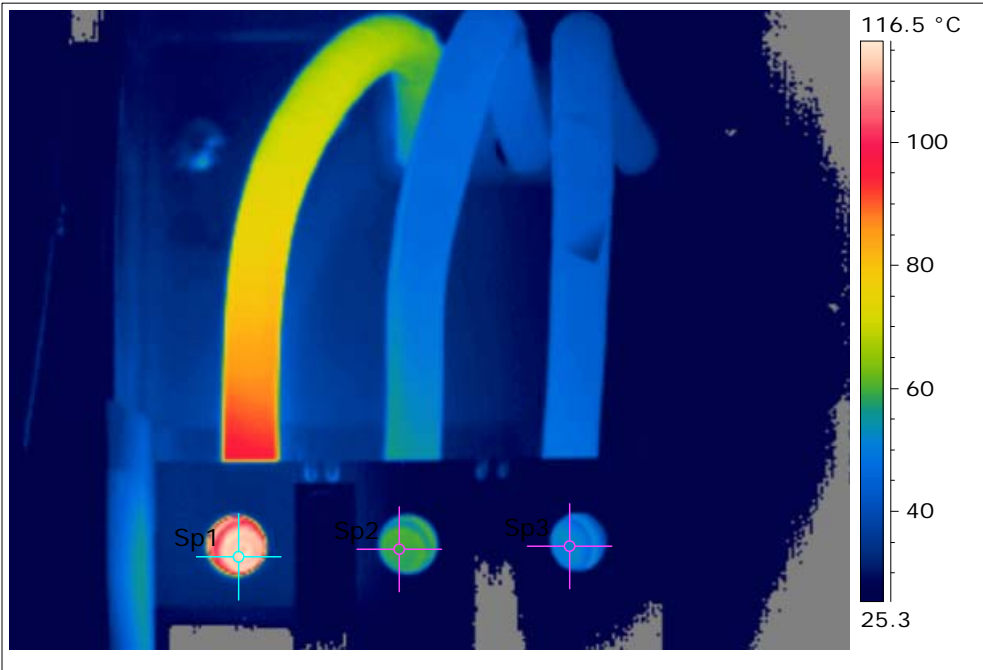
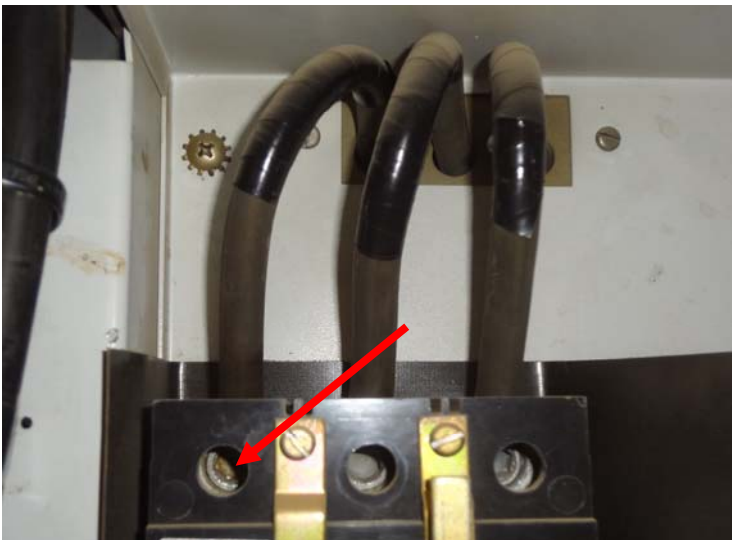
**Capacitor 80 KVAR**

Repair Probable Poor Connection @ A Leg on the Line / Load Side of the 150 Amp Square D Breaker.  
- Check Internal Contacts.

SP1 = A Leg  
SP2 = B Leg  
SP3 = C Leg

MCC Location: Main Electrical Building MCC #2	Filename: IR_37064.jpg
Equipment: Capacitor 80 KVAR	Camera Type: FLIR GF309
Load Factor: Balanced Load @ 91 Amps	Camera Lens: FOL23
Fault: Probable Poor Connection	Emissivity: 0.96
Date: 09/03/2015	Sp1: 113.4 °C
Time: 8:39:35 AM	Sp2: 58.7 °C
	Sp3: 52.3 °C

**Repair As Soon As Possible**

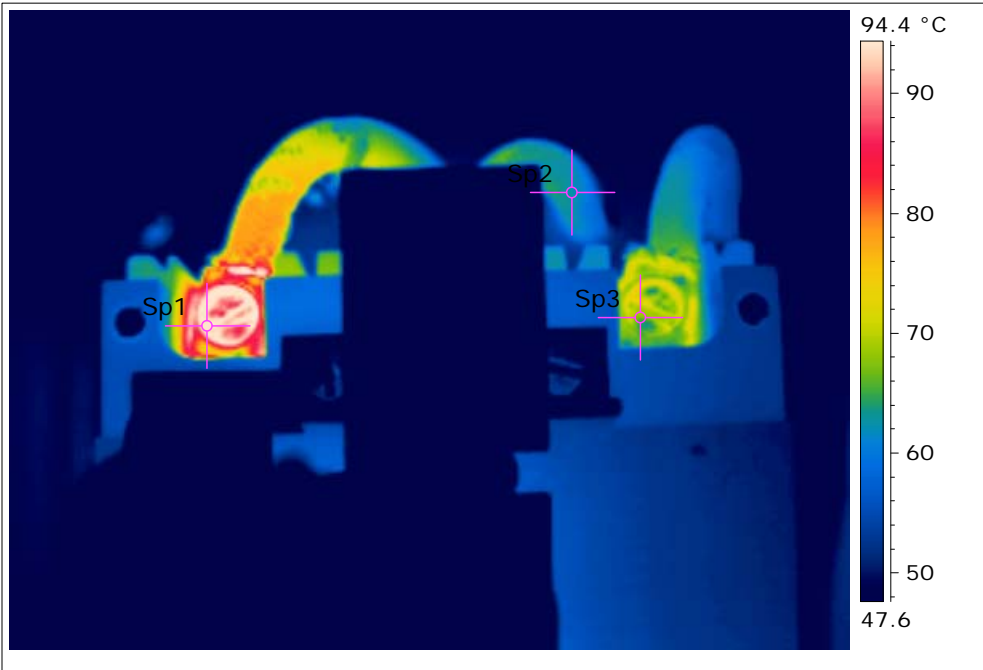
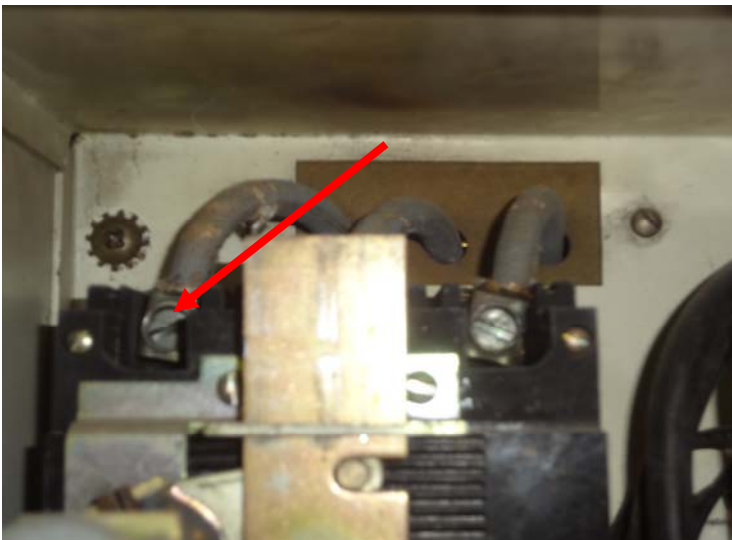
**PM18.18 Glycol Water Pump**

Repair Probable Poor Connection @ A Leg on the Line Side of the 100 Amp Square D Breaker.

SP1 = A Leg  
SP2 = B Leg  
SP3 = C Leg

MCC Location: Main Electrical Building Emergency MCC	Filename: IR_37069.jpg
Equipment: PM18.18 Glycol Water Pump	Camera Type: FLIR GF309
Load Factor: Balanced Load @ 39 Amps	Camera Lens: FOL23
Fault: Probable Poor Connection	Emissivity: 0.96
Date: 09/03/2015	Sp1: 100.7 °C
Time: 9:22:52 AM	Sp2: 62.1 °C
	Sp3: 66.4 °C

**Repair As Soon As Possible**

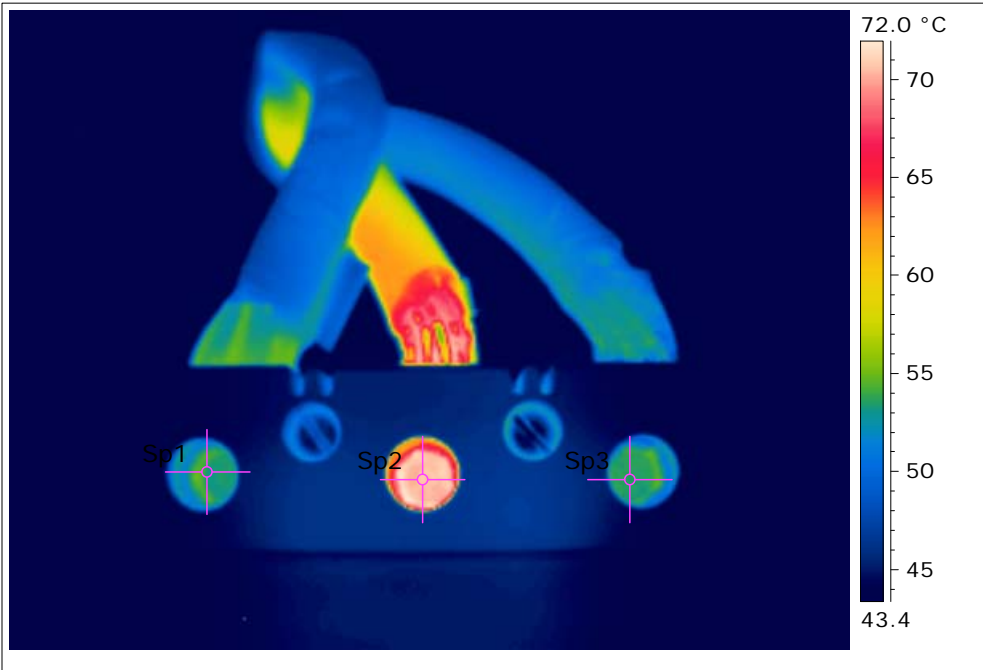
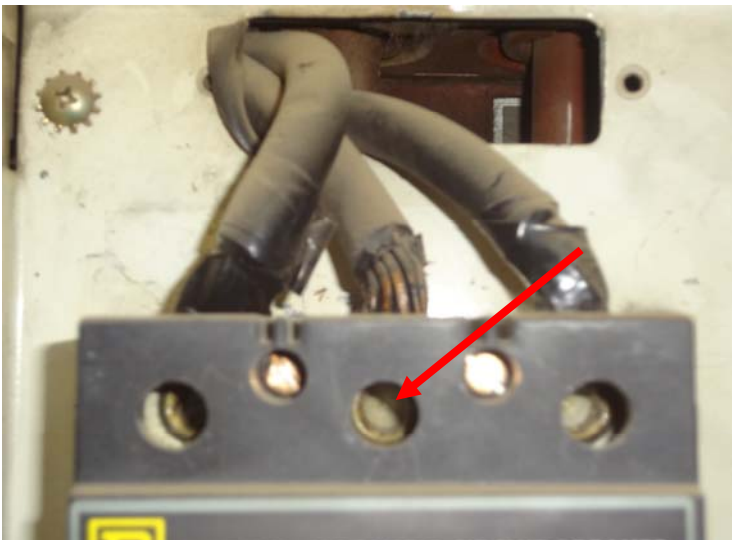
**Auto Transfer Switch**

Repair Probable Poor Connection @ B Leg on the Line Side of the 225 Amp Square D Breaker.

SP1 = A Leg  
SP2 = B Leg  
SP3 = C Leg

MCC Location: Main Electrical Building Emergency MCC	Filename: IR_37071.jpg
Equipment: Auto Transfer Switch	Camera Type: FLIR GF309
Load Factor: Load @ 114 Amps	Camera Lens: FOL23
Fault: Probable Poor Connection	Emissivity: 0.96
Date: 09/03/2015	Sp1: 53.3 °C
Time: 9:297:48 AM	Sp2: 70.6 °C
	Sp3: 53.6 °C

**Repair @ Next Downtime**
