Refractory
Inspection Report

CT 201 / Duct Expansion Joint

HR-15.54 Waste Heat Exchanger

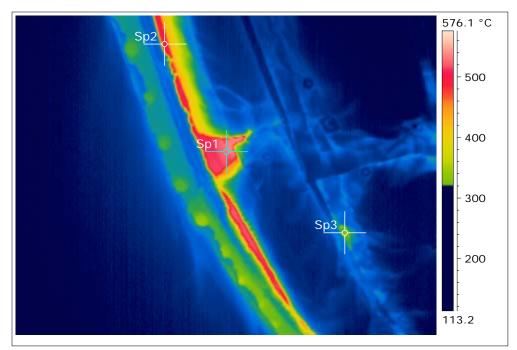
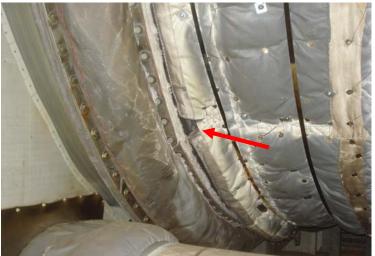
The infrared view shows the exterior metal surface with varying thermal patterns.
Temperatures have decreased slightly from the last inspection.

Equipment: CT 201 / Duct Expansion Joint	Filename: IR_0347.jpg
Elevation: West Elevation	Camera Type: FLIR GF309
Additional: Lower Section	Camera Lens: FOL23
Date: 2/6/2014	Emissivity: 0.95
Time: 8:41:08 AM	Sp1: 527.2 °C
	Sp2: 500.4 °C
	Sp3: *332.2 °C

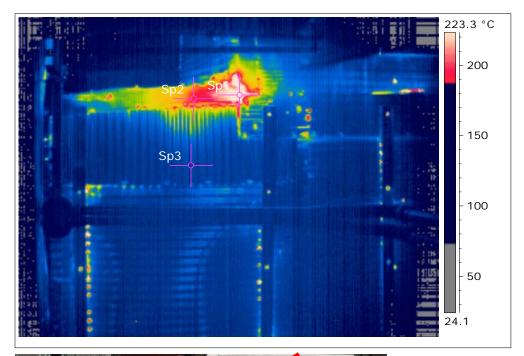
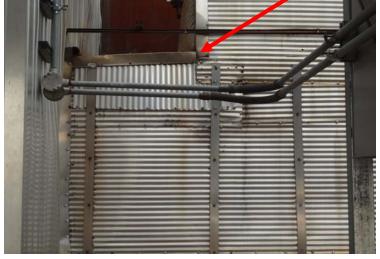
The infrared view shows the exterior metal cladding with heat loss along the upper corner.

Sp1= High Temperature Sp2= Spot Temp= 181.7C Sp3= Reference Temp= 68.3C

Equipment: HR-15.54 Waste Heat Exchanger	Filename: IR_11663.jpg
Elevation: South Elevation	Camera Type: FLIR GF309
Additional: West End By Building	Camera Lens: FOL23
Date: 23/01/2014	Emissivity: 0.95
Time: 11:05:34 AM	Sp1: 355.4 °C
	Sp2: <185.9 °C
	Sp3: <185.9 °C
